A sporting challenge

NL4
2014

The turf on sports fields, especially of large stadiums, represent an important issue - not only in terms of sport - but also as one of the largest cost drivers. Therefore, the monitoring and maintenance of the lawn takes on a special significance. PlantCare has installed a soil moisture monitoring system as part of the redesign of the entire pitch range of the St. Jakob -Park stadium in Basel. Soil moisture and soil temperature are measured at different positions and the measured data are transferred wirelessly in the control room situated behind the grandstands.

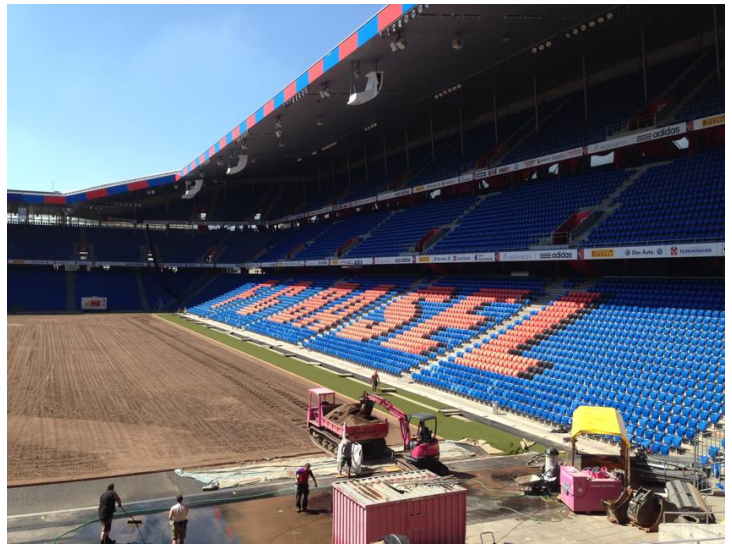
Due to the different shading of the lawn, in recent years it was not without problems to irrigate correctly. The lawn was locally too dry and on other areas too wet and so the operator decided on a complete renovation of the entire playing surface. At the same time the irrigation system has been reinstalled.

To get a better overview of the soil moisture and their differences, PlantCare was commissioned to install a monitoring system that measures soil moisture and soil temperature at the face-off spot and at the four corners of a certain depth. Thus, the Greenkeeper always has a current overview of the moisture condition of the play ground.

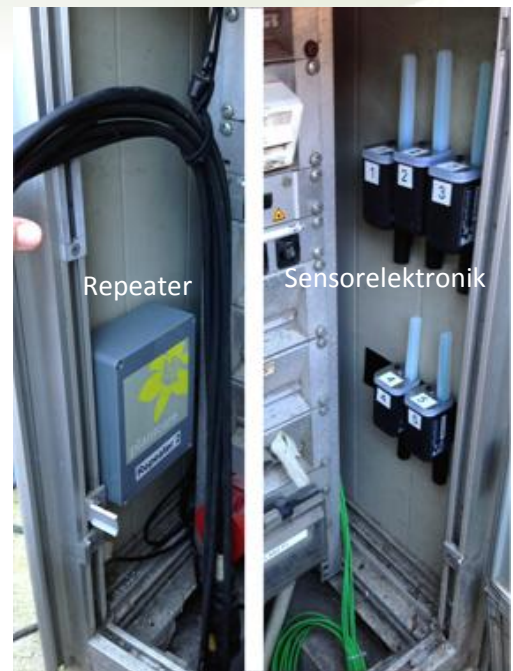
This problem could be successfully solved also: The electronics of the five sensors were attached to the right housing wall of the electrical cabinet. On the opposite side a repeater has been attached, which take-on the signals from the sensors and emits them again with higher energy. In order to get the signal out of the metal cabinet, an external antenna is used, which now transmits the radio signals in the control room.

In the control room there is a second repeater that receives the signals and transmits them on another radio frequency to the controller, where the data finally are displayed on a screen.

Another challenge was that the sensor electronics of all five sensors must be housed in a metallic electrical cabinet for reasons of possible vandalism. From there, the radio signal must be transmitted out of the cabinet and through the reinforced concrete bleachers in the underlying control room.

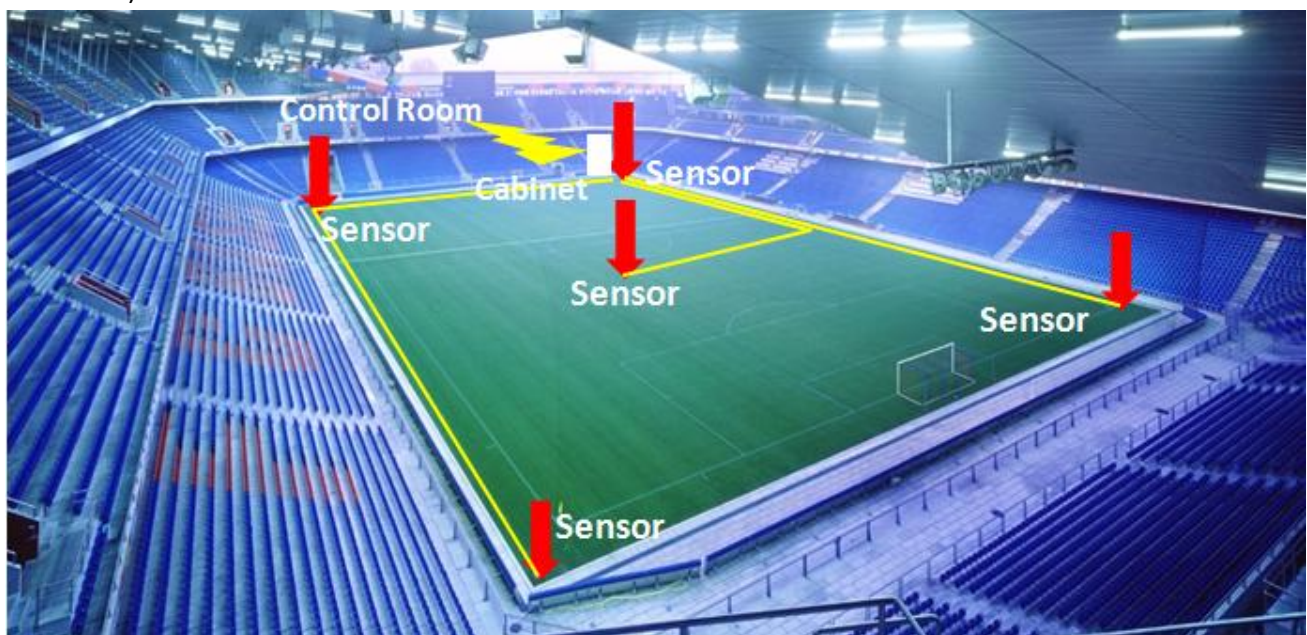
A special issue also resulted from the special substrate used as turf base. This substrate, understandably, has a high water permeability, otherwise puddles would immediately appear in case of rain. The high water permeability corresponds to a low field capacity of the soil. Correspondingly, the felt used in our sensors has to have a low field capacity also. Therefore, the most suitable felt for this demanding application had to be selected in laboratory tests. Measurements have shown a field capacity of approximately 65% (100% = full saturation).
